S&S Jerseyland Dairy

7900 Old Elm Rd

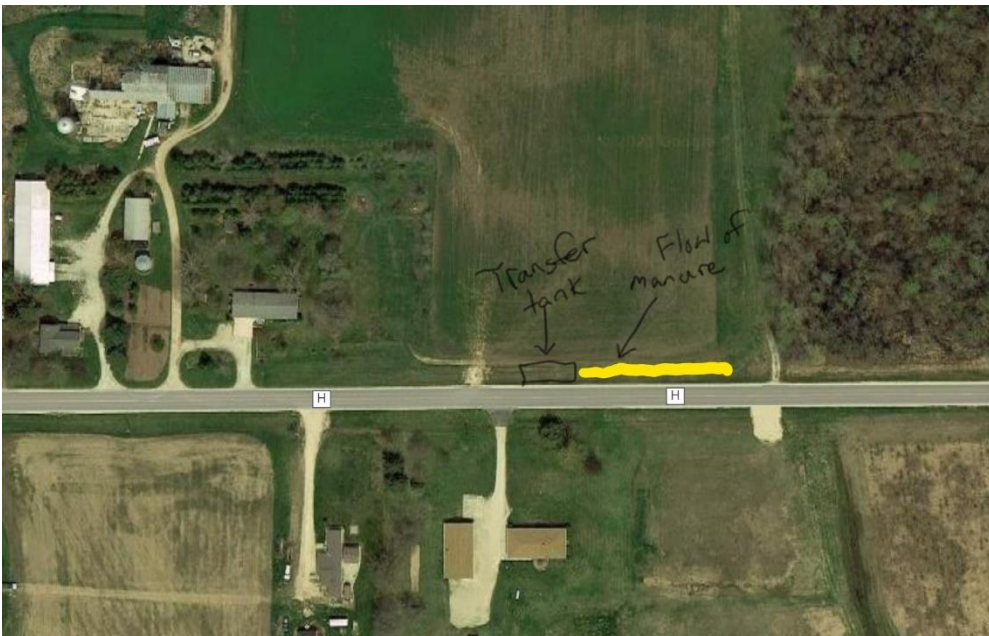
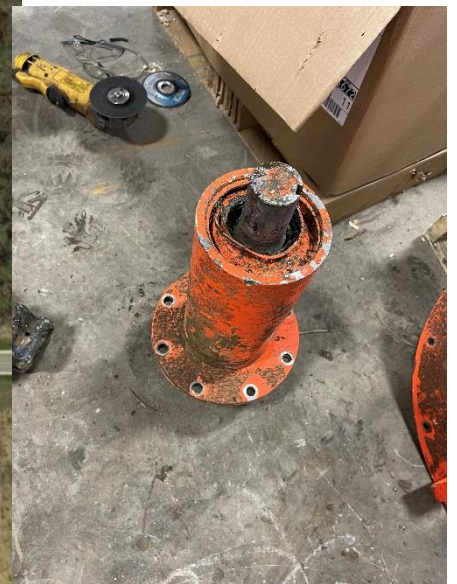
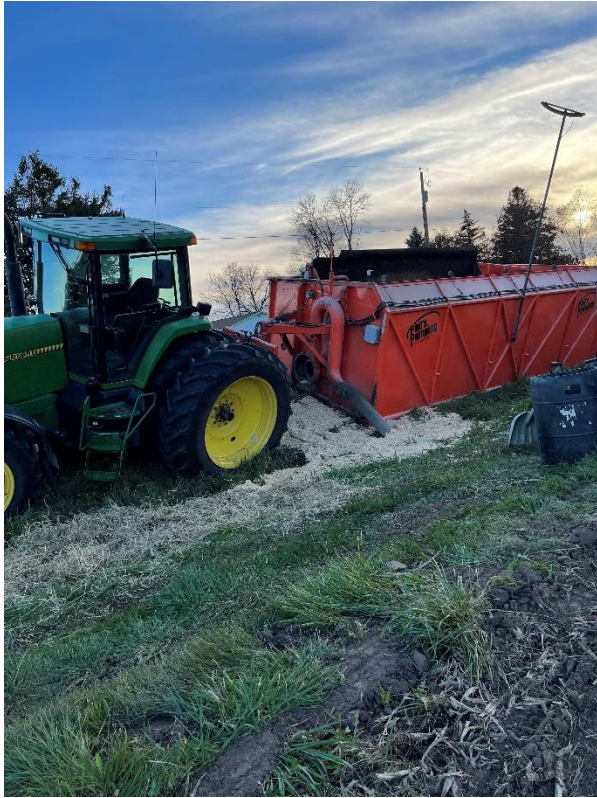
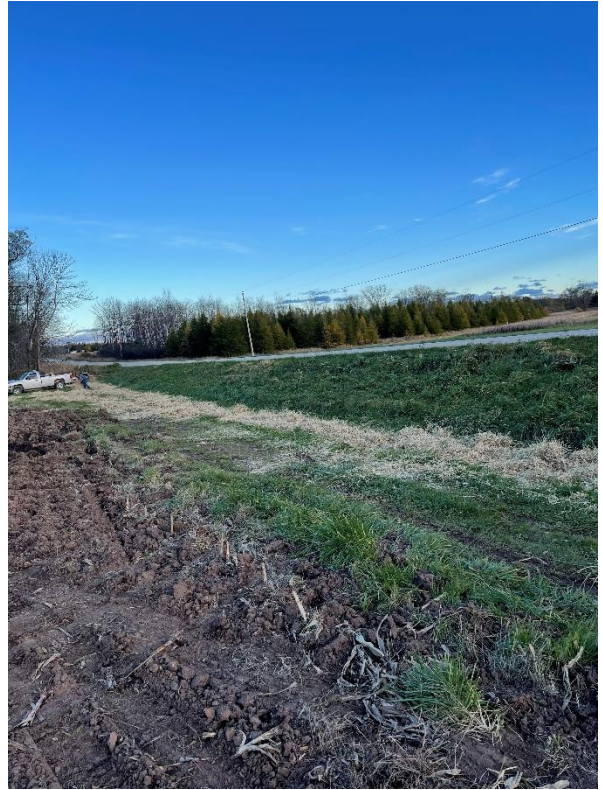
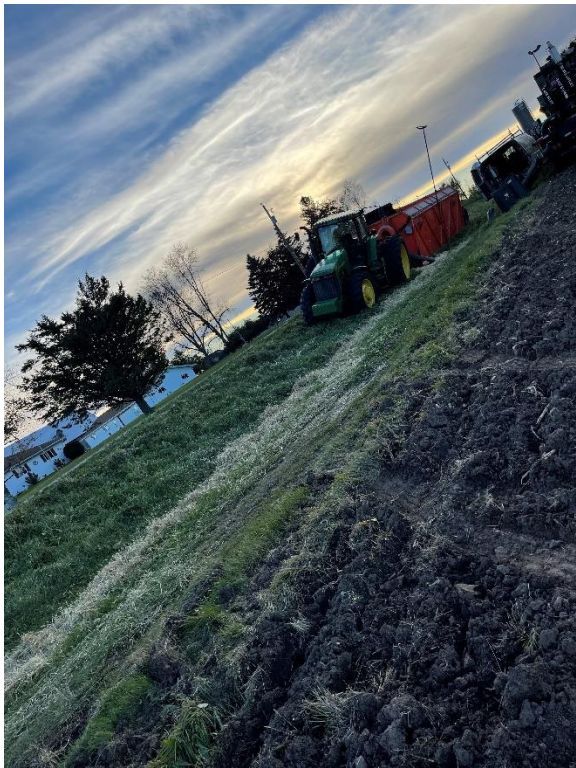
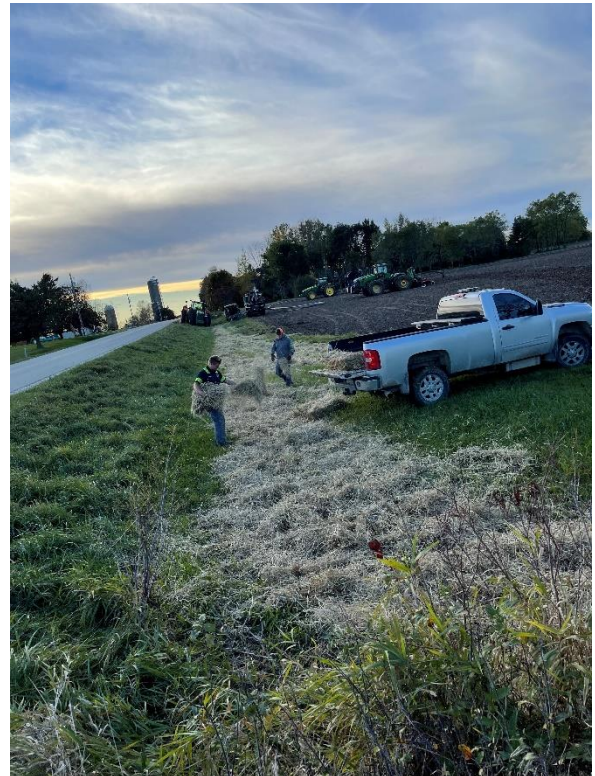
- The spill was caused by a mechanical failure on the transfer tank. A bearing failed on the driveshaft for the pump on the transfer tank, which caused a seal to fail that separates the manure from the bearing tube. When the seal failed it allowed manure to escape from the pump and out of the bearing tube.

- The spill was contained by using sawdust shavings that were on site to stop the manure from running further down the ditch line. Staff at the site immediately called for additional straw and sawdust to be brought to the site of the spill. Once the straw had arrived, it was dispersed throughout the ditch line to soak up any additional manure on the surface.

- It's estimated that approximately 100 gallons of manure was recovered with the straw and sawdust shavings.
- No berms, sumps, or any other structures were built or used to contain the spill.

- To prevent any similar issues from happening, we are planning on replacing the bearing tube on the transfer tank annually to prevent any excess wear on the bearings.
